ETHICON, INC.

SEVEN YEAR DATA FOR TEN YEAR PROLENE™ STUDY: ERF 85-219

Interim report on the physical testing of PROLENE, PVDF, ETHILON & NOVAFIL after seven year subcutaneous implantation in the Beagle Dogs - TEN YEAR BSR STUDY, STH211-92, 85-219

TEN YEAR PROLENE BSR STUDY
7-YEAR DATA SUMMARY

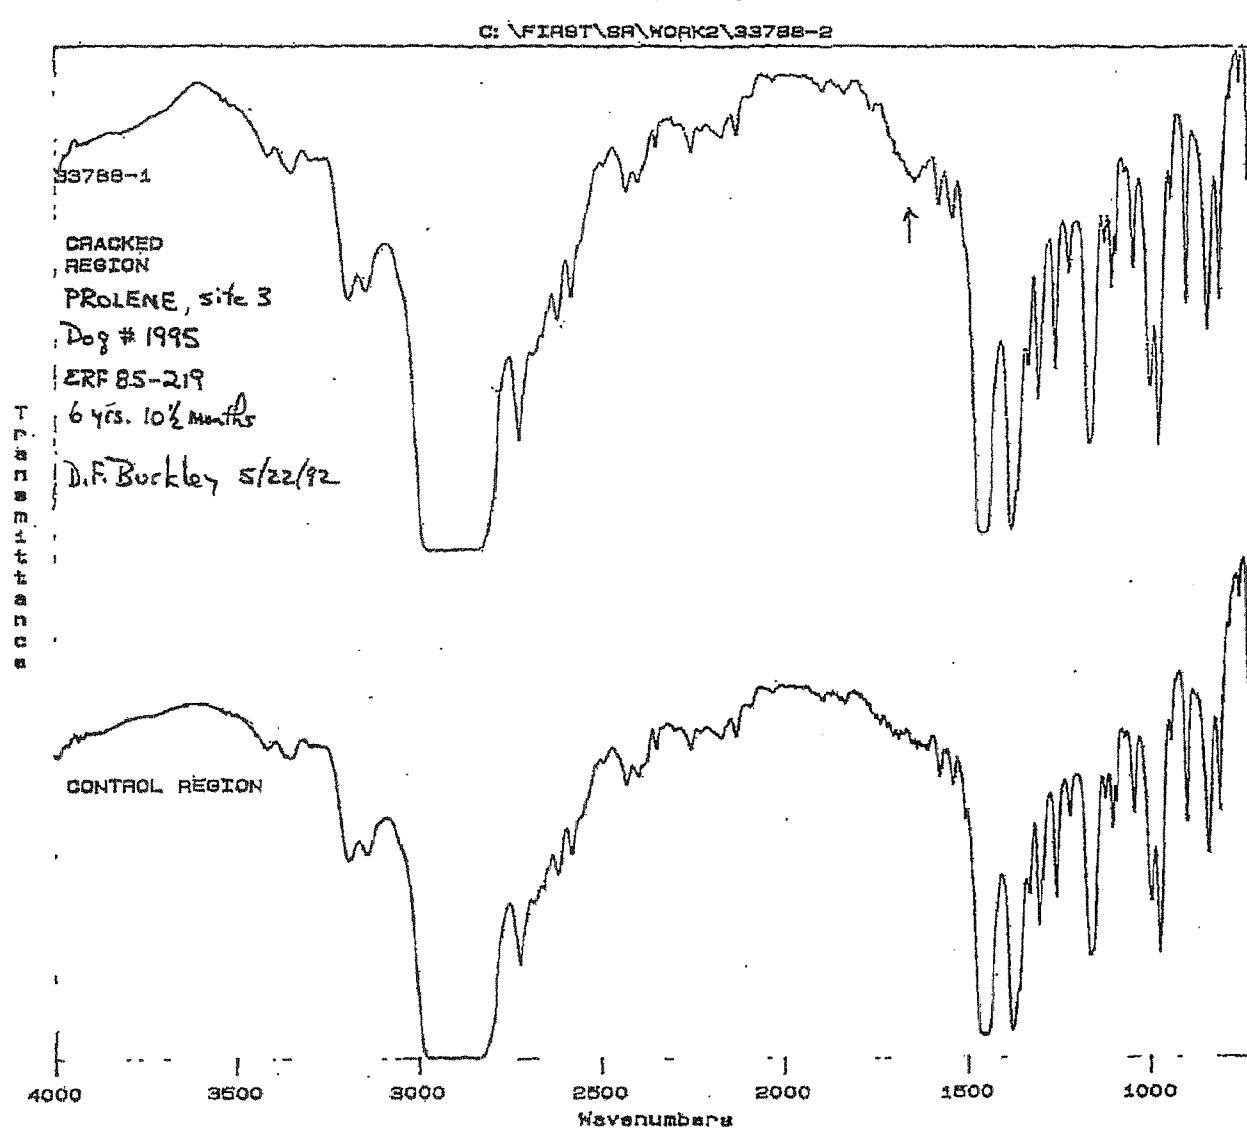
Figure A - Comparison IR Spectra of Cracked and Non-cracked Regions of PROLENE (SR33788)

IR microspectroscopy was used to examine cracked areas in ETHILON, Novafile and PROLENE™ explants. IR spectra obtained for cracked PROLENE specimens (Figure A) showed possible evidence of slight oxidation (a broadened weak absorbance at about 1650 cm⁻¹). IR spectra obtained for cracked areas of ETHILON and Novafile did not differ from uncracked areas (Figures B and C), but expected IR absorbances for oxidation would be masked by the strong carbonyl absorbances normally observed for these sutures. Figures D and E show pictures of the areas examined by IR microspectroscopy for ETHILON and Novafile.
